Boeing 737-436, G-DOCE

AAIB Bulletin No: 6/2004	Ref: EW/C2003/05/06	Category: 1.1
INCIDENT		
Aircraft Type and Registration:	Boeing 737-436, G-DOCE	
No & Type of Engines:	2 CFM56-3C1 turbofan engines	
Year of Manufacture:	1991	
Date & Time (UTC):	30 May 2003 at 1630 hrs	
Location:	In flight near Lyon, France	
Type of Flight:	Public Transport (Passenger)	
Persons on Board:	Crew - 6	Passengers - 128
Injuries:	Crew - None	Passengers - 7 (Minor)
Nature of Damage:	Burnt wiring loom	
Commander's Licence	Air Transport Pilots licence	
Commander's Age:	34 years	
Commander's Flying Experience:	8,000 hours (of which 1,500 were on type)	
	Last 90 days - 100 hours	
	Last 28 days - 40 hours	
Information Source:	AAIB Field Investigation

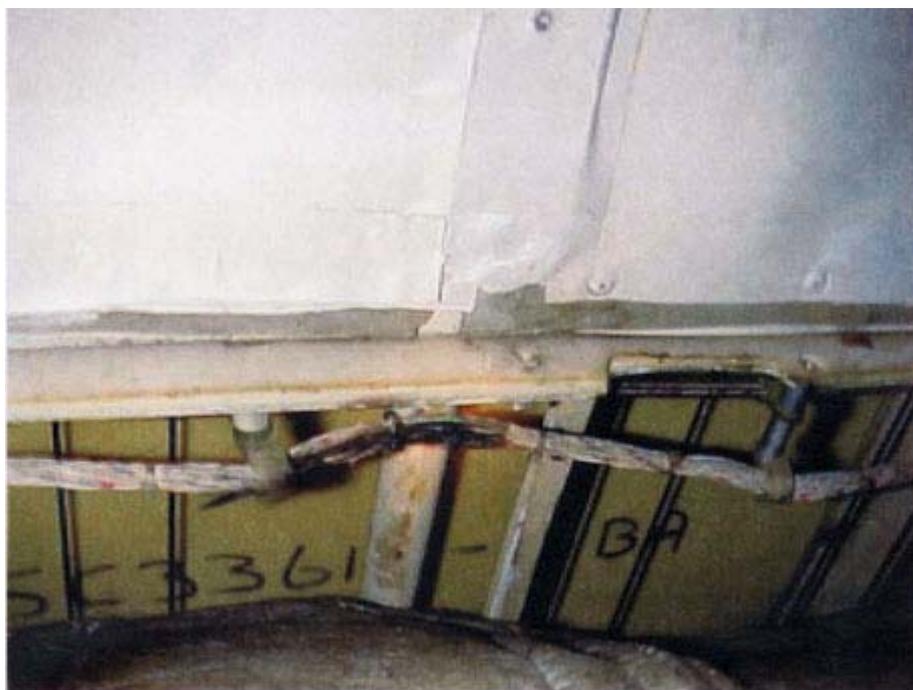
Figure 1 Loom Damage

The replacement of the OFV failed to rectify the problem, and so the next course of action was to replace the pressure controller. The system, however, remained inoperative. The associated wiring was now inspected and it was during this check it was discovered that a wiring loom had become overheated and burnt. This was in an area just aft of the aft cargo hold where the wires ran across the top of the cargo hold but below the cabin floor. The burning damage on the loom extended from a 'p-clip', over a length of about 2 inches. In the centre of the damaged area was a 'zip' loom retaining strap, which had melted, and all damage was limited to the wiring loom, p-clip and 'zip' strap, shown in Figure 1. The wires were removed and the AAIB were then informed of the findings.

The wire loom that was damaged, W298, contained all the wires between the pressure controller and the OFV. This meant that the wiring associated with all four modes of operation was included in the same loom. Wires which connected to the aft drain mast heater, the aft door warning system and the

The damaged wires were examined in detail, in conjunction with the AAIB, by a specialist organisation. It was concluded that the failure had most likely been initiated by long term fretting of the wire bundle at a fixed point in the aircraft, such as a 'p-clip' or 'zip' strap. The fretting had resulted in abrasion of the cable jacket and insulation, and exposure of the conductors, with subsequent short circuits leading to failures of the associated circuits and burning of the loom. The initiating area of the failure could not be established due to the damage, but copper deposits on the 'p-clip' indicated that it started either close to, or within, the 'p-clip' area. There was no evidence of 'carbon arc tracking'.

From the evidence it is clear that the de pressurisation event on G-DOCE resulted directly from a wiring failure in a loom at the rear of the aft cargo hold. The initiation of the failure was probably due to fretting of the wiring insulation against a 'p-clip' or 'zip' strap, which allowed the conductors to become exposed and short to each other. It is likely that this allowed erroneous signals to be sent to the OFV, causing it to start to open, thus increasing the cabin altitude. The AUTO system then failed and passed control to the STBY system. However, as the cabin altitude continued to climb, the STBY light extinguished which indicated that this system had also failed. As the wires for the STBY system run through the same loom as those for the AUTO system, it was likely that an erroneous signal was picked up by the pressure controller, causing it to fail the back-up system. AC MAN was then selected but, as the OFV AC feedback wire was damaged, the indicator on the PCP appeared to show that the valve was closed and not responding to any switch inputs, whereas the valve was probably operating. The QAR data showed that the OFV must have been partially closed, as the cabin pressure remained in excess of ambient during the ensuing descent; if the valve had remained in the position associated with the de-pressurisation, the cabin altitude would eventually have matched the aircraft altitude.

The results of the wiring loom examination revealed that its failure was most likely triggered by the abrasion of the insulation of two or more of the affected wires. This may have been caused by the 'p-clip' or the loom 'zip' straps in response to normal vibration and associated movement of the loom, especially if they had not been correctly installed. It is also possible that the loom may have been damaged whilst maintenance was carried out in the area, and this may have started the process which led to the conductors being exposed.

It is recommended that in order to prevent failure of the cabin pressure control system in the event of damage to wiring loom W298, the Boeing Commercial Airplanes should consider, on the Boeing 737-436 and similarly configured models, separating or protecting the wiring associated with the different modes of operation of this system, which connects the cabin pressure controller to the rear outflow valve, such that any single point failure of the loom would not result in effective failure of the pressurisation control system.
